SEDIMENT TRANSPORT, WATER
QUALITY, AND CHANGING BED
CONDITIONS, TUCANNON
RIVER, SOUTHEASTERN WASHINGTON

Prepared For
USDA Soil Conservation Service
Spokane, Washington

April, 1982

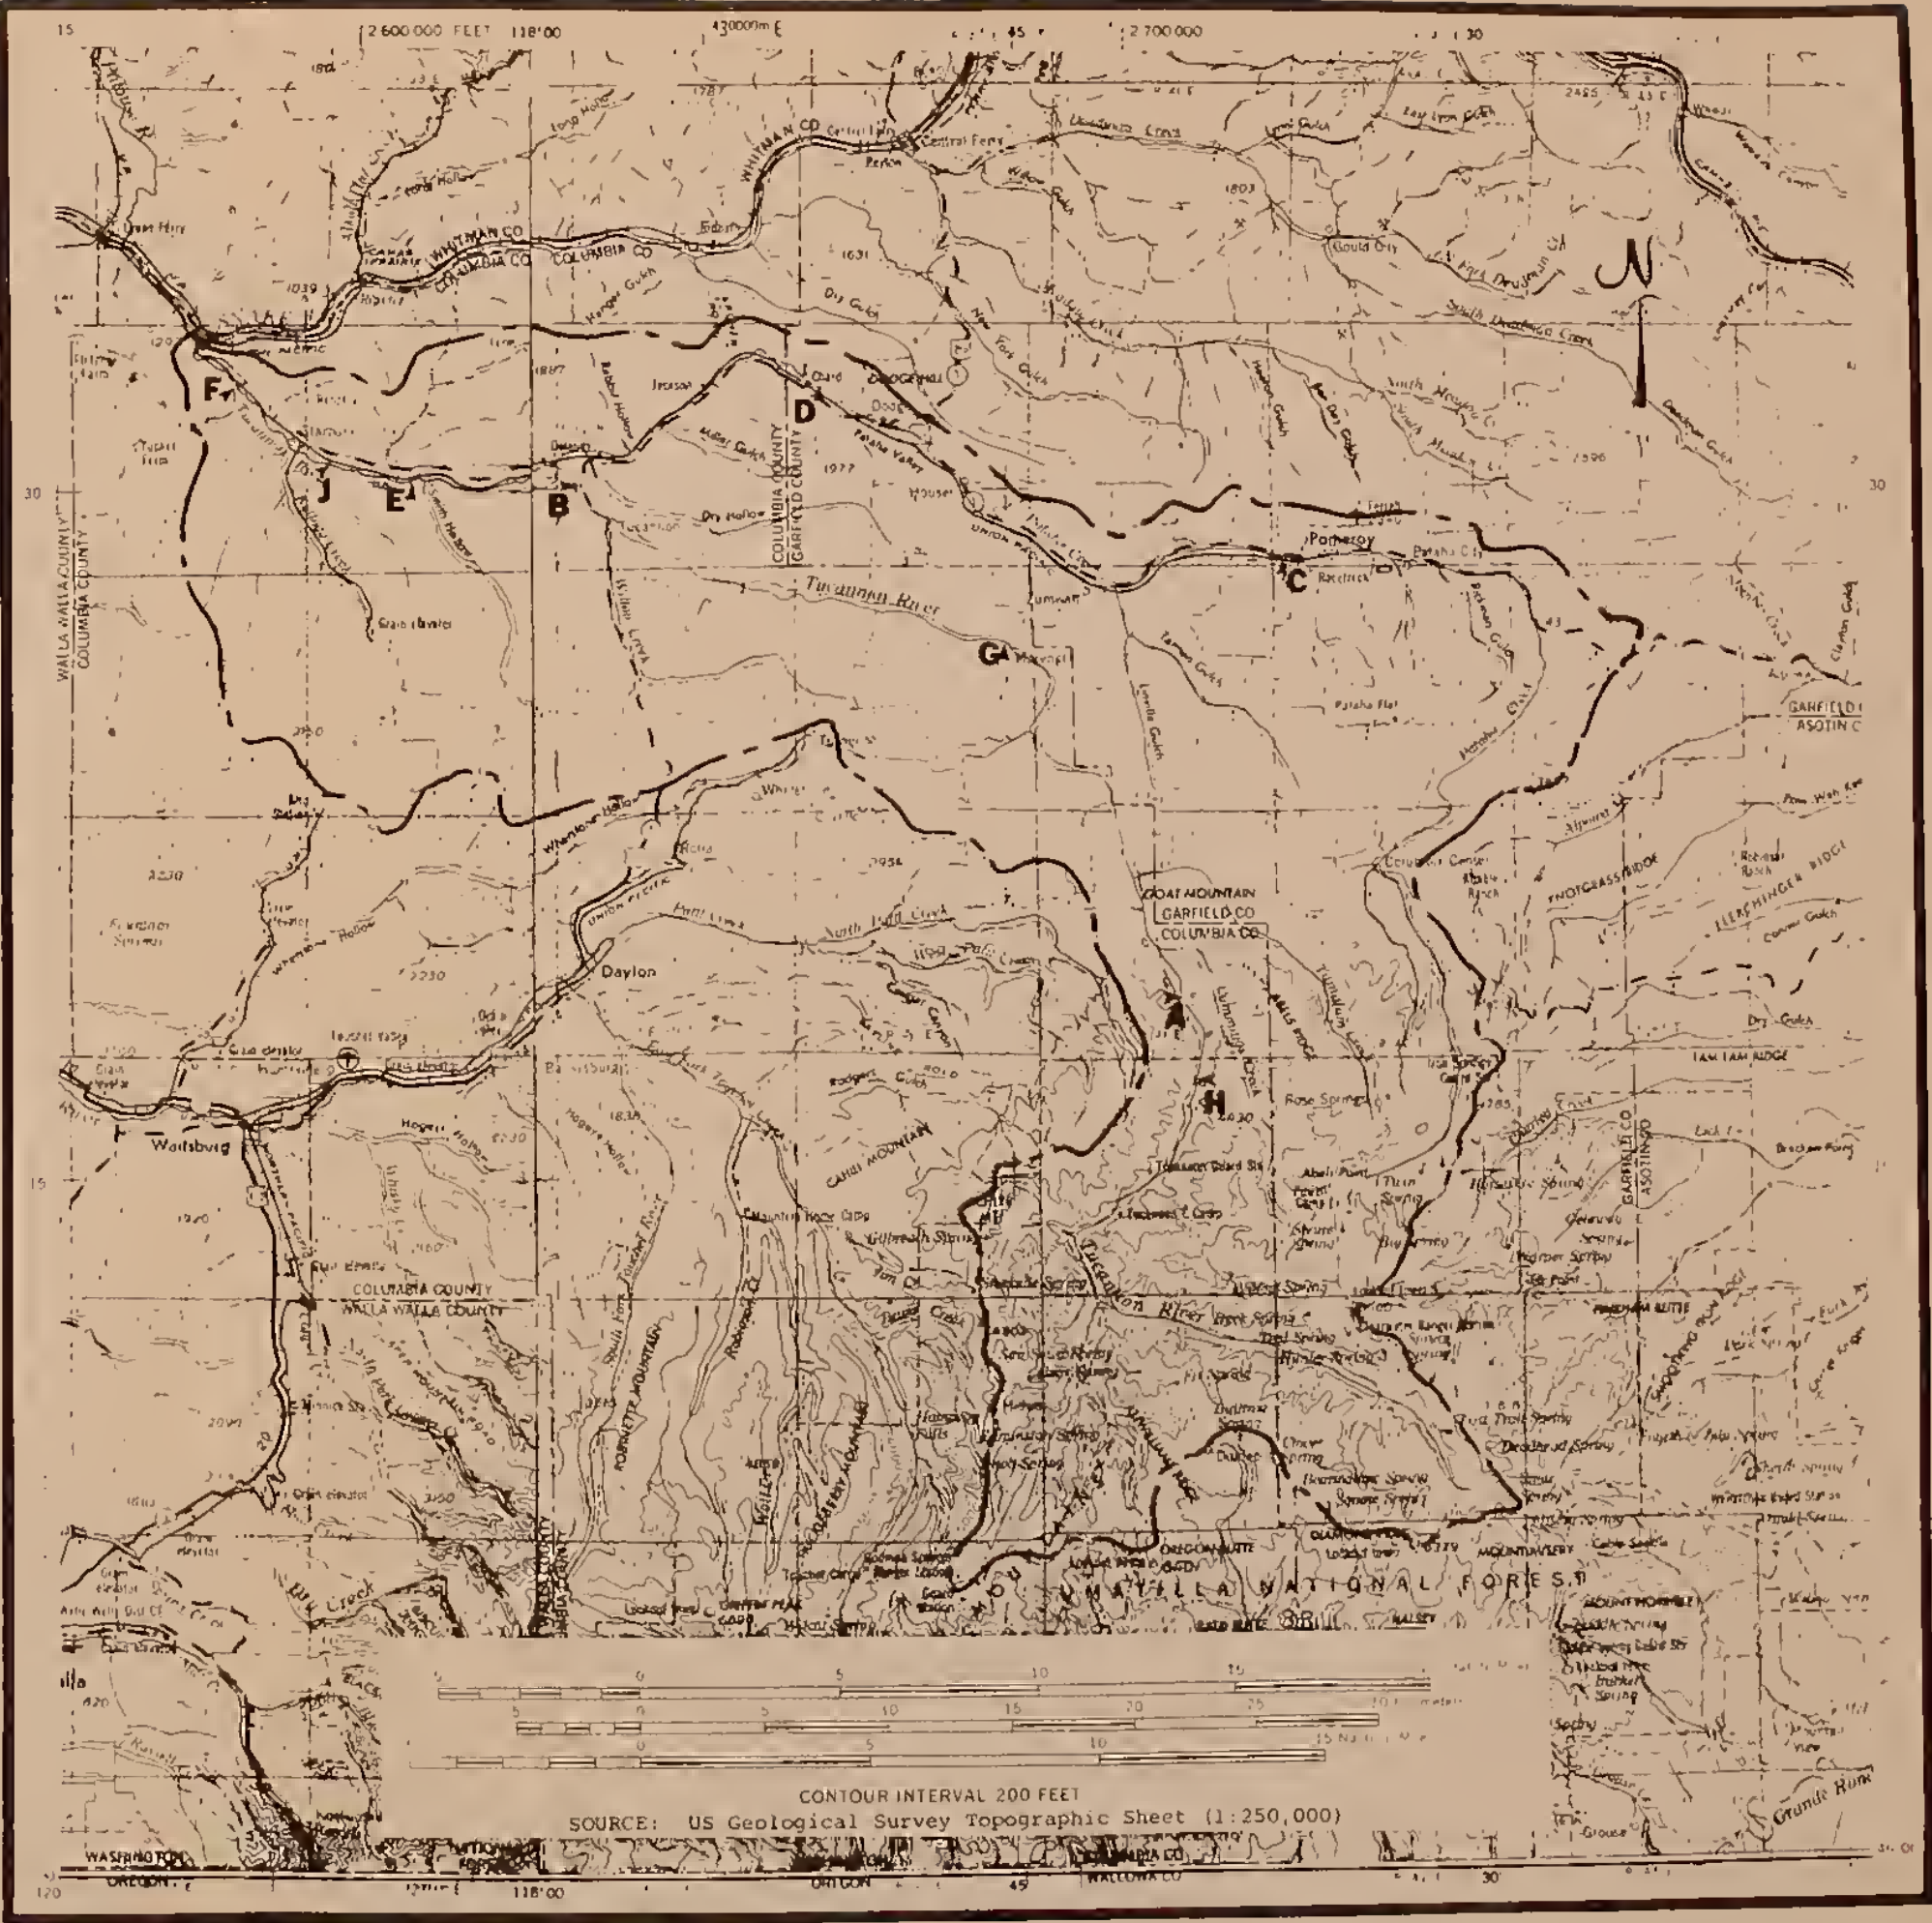
Figure 1.1.
Topographic Map of Tucannon
Watershed and Vicinity.
Monitoring program is explained
in Appendix A and in text.
